**North Bank Playground****Completed By: Patrick McCord****Date of Report: March 17, 2020****Time of Observation: 1:00 PM**

North Bank Playground

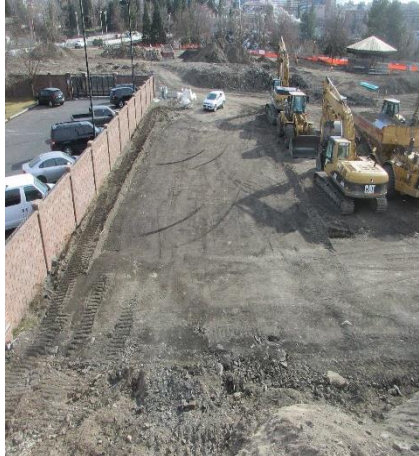
#1 View from cliff east side of the cliff (facing south)

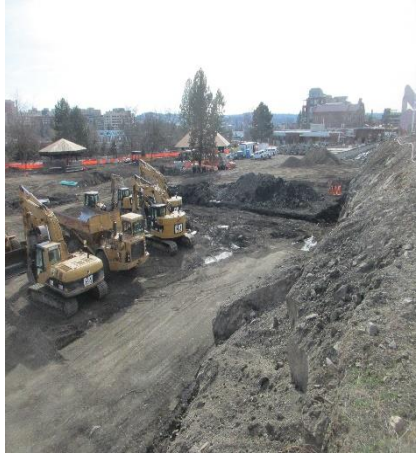
#2 View from east side of the cliff (facing west)

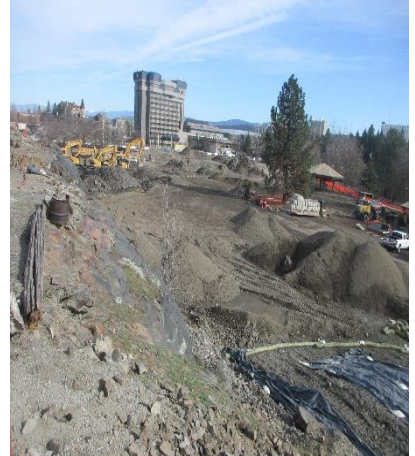
#3 View from west side of the cliff (facing east)

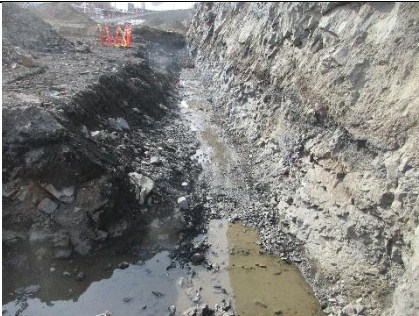
#4 Storm line trench at cliff.

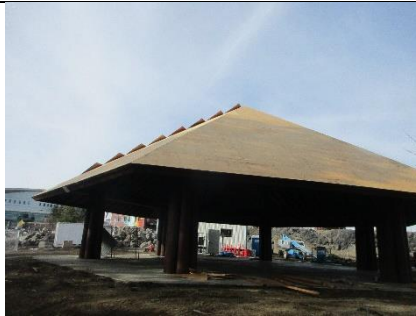
#5 Plywood installation at large shelter.

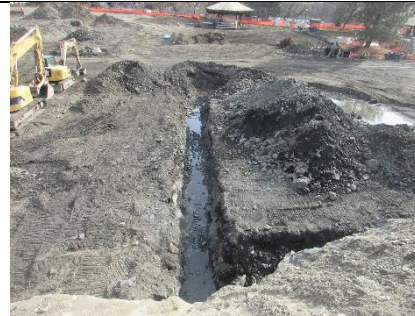
#6 Storm trench under skate park.

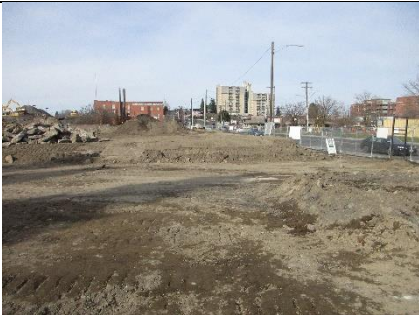
#7 View from southeast corner (facing north).

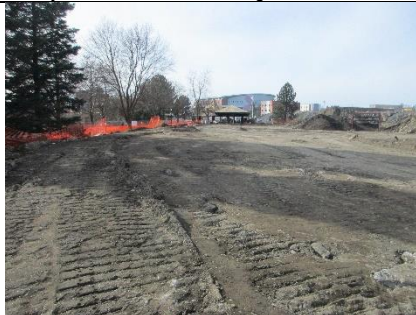
#8 View from southeast corner (facing west).

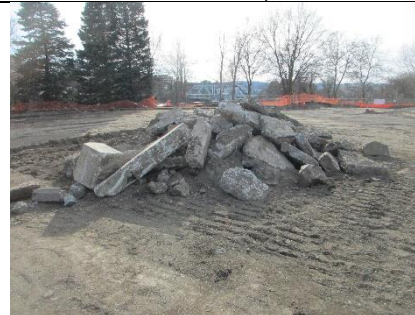
#9 Debris pile.
